DRONE-ASSISTED VISUAL INSPECTION · PRE-DEPLOYMENT

Pre-Deployment Rigging Inspection

[REDACTED]	REVISION 0	[REDACTED] 16
[REDACTED]		PREPARED BY AURORA MEDIA HUB

Drone-assisted visual inspection of rigging aids and lifting equipment ahead of the lifting and installation of [REDACTED] assets, conducted under [REDACTED] – Management of Change.

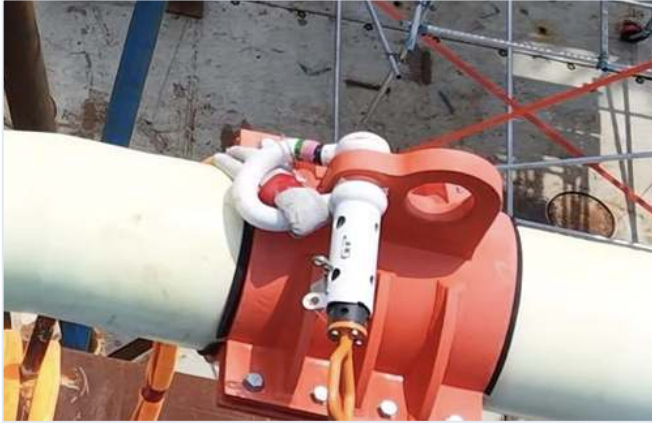
FIG 3.1-A — R-CLIP RETAINED IN ROV SHACKLE, PLEM HUB

Upon closer aerial inspection of the ROV-deployed shackle, it was identified that an R-clip had been inadvertently left in place. The component was lodged within the shackle mechanism but posed no immediate operational hindrance.

Based on the orientation and approach angle, it was determined that the sling eye would clear the bow of the shackle without risk of snagging or interference. No modification or recovery intervention was deemed necessary.

The anomaly was assessed as non-critical. Disconnection proceeded without incident, with all parameters within safe operational limits.

The ROV team was pre-emptively alerted. A review of the manufacturer's shackle manual confirmed that the R-clip's function is solely to secure the pin in the open position, which was not relevant to the planned operation.

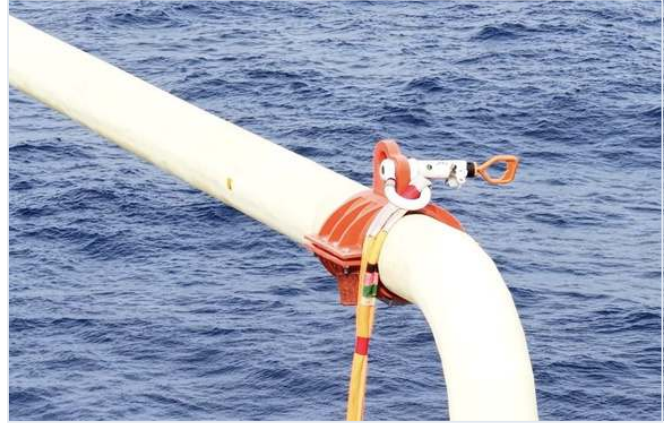
FIG 3.1-B — SHACKLE ORIENTATION & SLING EYE APPROACH

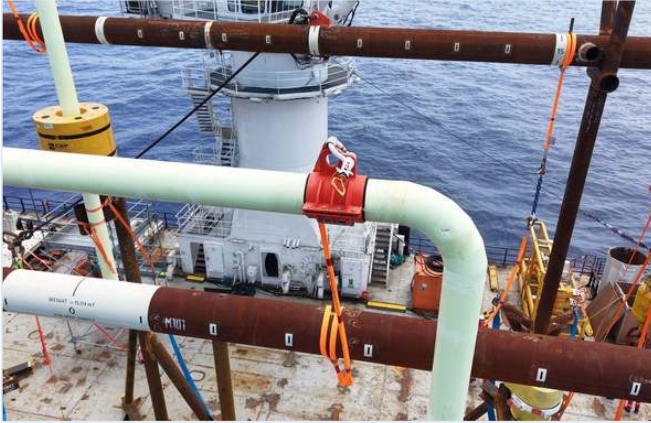
FIG 3.2-A — SHACKLE 2, CENTRE POSITION

Inspection of Shackle 2 revealed that a pin was again present within the shackle body. No deviation from intended setup was observed, and the hardware remains in a mechanically sound configuration.

All observable rigging elements are currently in a favourable and safe configuration. Proceed with operation under routine visual observation during the lift-off phase to confirm maintained positioning.

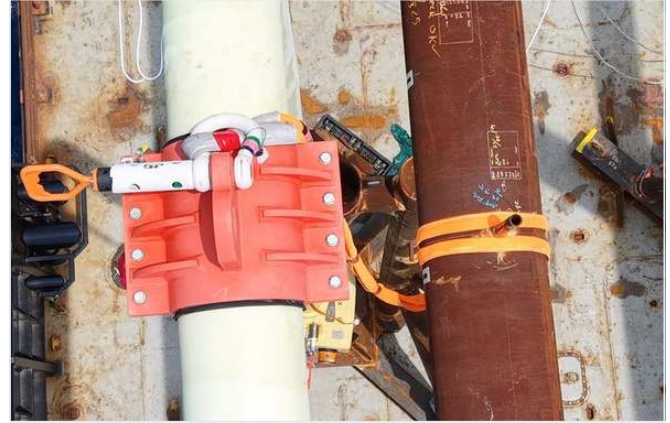
FIG 3.2-B — SLING EYE SEATED AT SHACKLE BOW TIP

The sling eye is correctly seated at the tip of the shackle bow, enabling clean and unrestricted tensioning. Its placement ensures no contact with the inner curvature or sharp edge of the shackle, thereby eliminating the risk of fouling during raising.

The loose end of the sling is currently flaked neatly over the clamp edge, presenting no immediate hazard. However, this position will require active monitoring during recovery or raising to ensure it does not shift into an unfavourable orientation as tension increases.

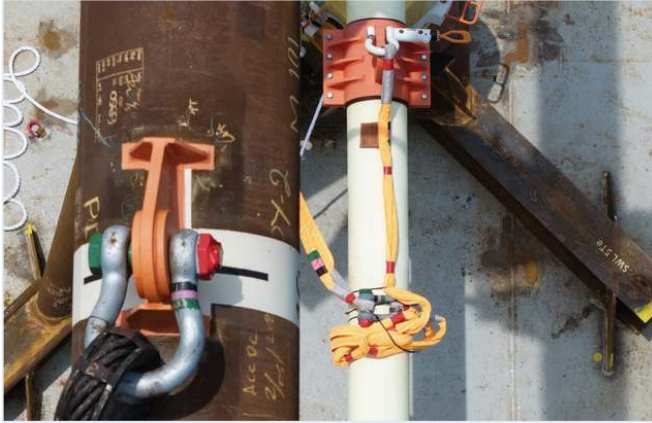
FIG 3.3-A — CHAIN LINKS & SPLIT PINS, TAPED AND SECURED

Aerial inspection confirmed the chain links and split pins were properly installed and secured using tape, effectively mitigating chafing risks. The sling eye was well-positioned in the shackle bow, with the shackle oriented upright for optimal alignment. The slings were bunched and fastened with cable ties, a positive measure to control excess length and reduce the risk of snagging beneath the lifting clamp. The R-clip had been removed, streamlining shackle release operations and eliminating unnecessary workload for the ROV team.

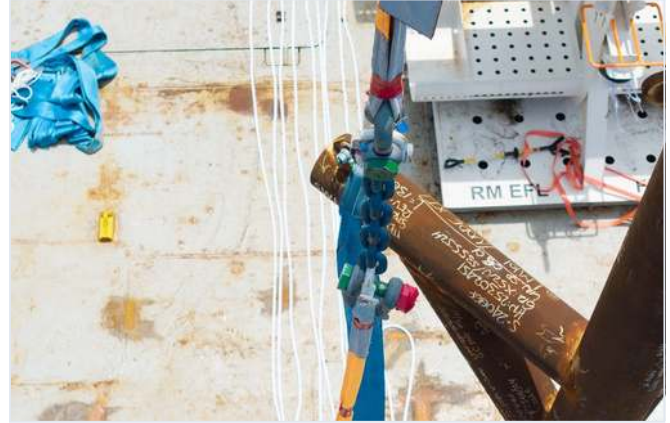
FIG 3.3-B — XT HUB SHACKLE, UPRIGHT ORIENTATION

Chains were observed hanging near the cradle support arm, with one shackle and lift sling located in close proximity to this area. This configuration introduces a potential snag risk during lift-off or dynamic motion.

It is advised to remove the cradle lift sling and associated shackle to eliminate this snag point. The active shackle currently in use was observed to seat the soft sling eye cleanly on the pin, with additional taping applied to prevent rotational movement of the eye. This taping ensures the sling and shackle do not rotate, allowing for even weight distribution and preserved balance during lift execution.

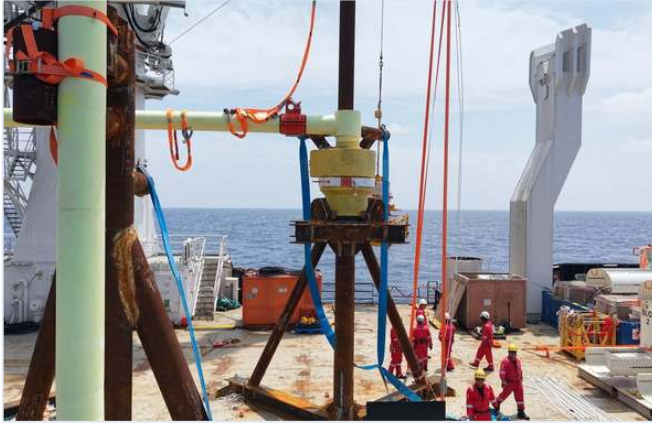
FIG 3.4-A — SOFT SLINGS CHOKED BENEATH SPREADER BAR

Visual inspection confirmed that all soft slings were correctly choked and oriented, with all load-bearing bights located beneath the spreader bar in accordance with rigging best practices.

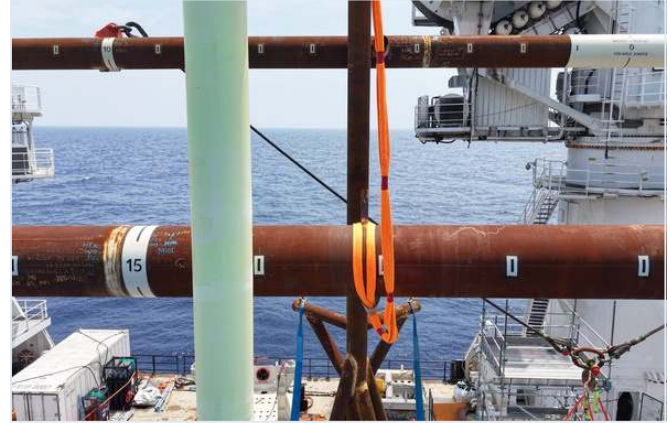
FIG 3.4-B — SLING TAILS PRIOR TO DRESSING

Loose excess sling tails were noted on several slings. These were not adequately secured and required additional dressing with cable ties to prevent uncontrolled movement during lift-off. A missing monkey's fist was identified on a hold-back sling; this was noted and rectified shortly after the inspection. Sling 3 at the XT-PLM side was observed to lack sufficient taping along its length. This omission posed a potential entanglement and thruster interference hazard for the ROV once subsea.

The issue with Sling 3 was flagged and addressed immediately, following identification via drone footage. All unsecured sling ends were subsequently tied down and re-verified prior to operations.

Slings are now in a safe, controlled configuration. Recommendation to include sling dressing checks in pre-deployment visual inspections to catch similar oversights in future lifts.

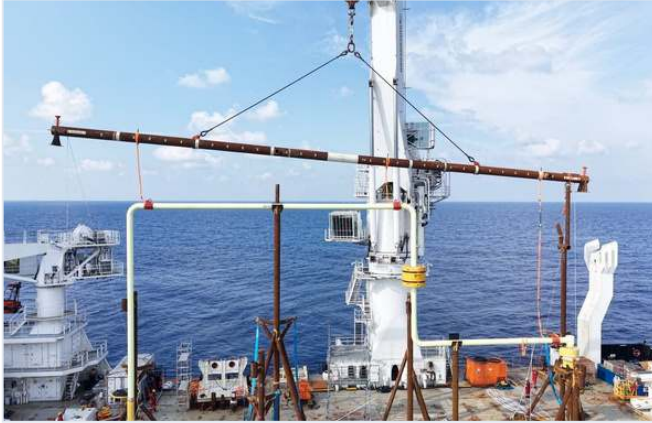
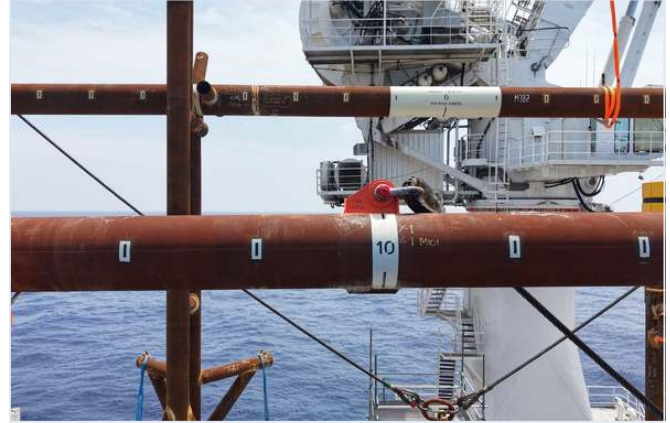
FIG 3.5-A — SPREADER BAR & CRADLE SUPPORT ARRANGEMENT

FIG 3.5-B — SPREADER BAR RIGGING, AERIAL VIEW

Chains were observed hanging near the cradle support arm, with one shackle and lift sling located in close proximity to this area. This configuration introduces a potential snag risk during lift-off or dynamic motion. Shackle and sling condition at the spreader bar connections is covered under the overview in Section 3.3.

It is advised to remove the cradle lift sling and associated shackle to eliminate this snag point. The active shackle currently in use was observed to seat the soft sling eye cleanly on the pin, with additional taping applied to prevent rotational movement of the eye. This taping ensures the sling and shackle do not rotate, allowing for even weight distribution and preserved balance during lift execution.

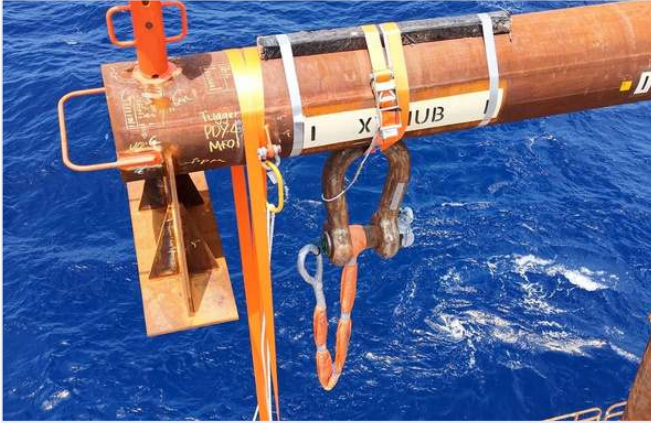
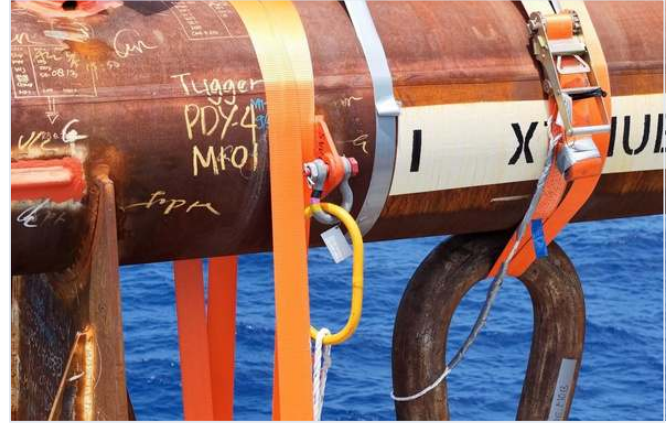
FIG 3.6-A — CLUMP WEIGHT SHACKLE RESTRAINT, CARGO STRAPS

FIG 3.6-B — CUT-AWAY RELEASE ARRANGEMENT & TIMBER PACKING

Shackles were secured using cargo straps, which incorporated sharp washers to enable cut-away subsea release by ROV. Timber planks were strategically positioned beneath the straps to create clearance for ROV knife access as a secondary detachment method. These combined elements introduced potential risk of shackle misalignment or unintentional release during transit, as well as tensioning interference against the cradles.

Aerial drone footage confirmed that all shackle assemblies remained in a safe, stable condition, with no visible evidence of movement, interference, or hazard escalation.

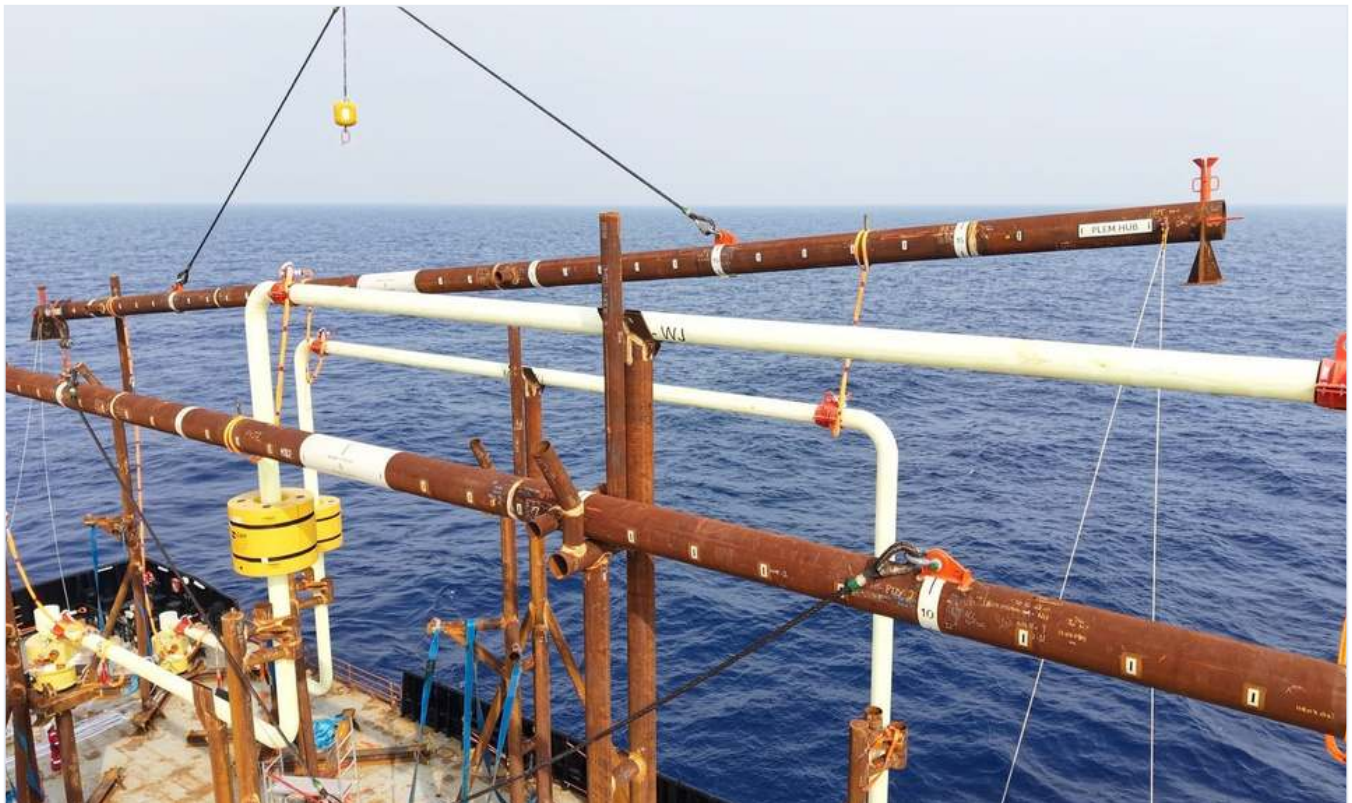
Following the initial deployment, drone footage revealed that the central (tall) cradle was not extended sufficiently. The clump weight created an angular offset, causing the centre of the spreader bar to lift off the cradle upright support prematurely, while the stern cradle remained in contact. These different-length supports, not accounting for the inclined bar during slack sling conditions, allowed the spreader to pivot unexpectedly around the stern upright cradle support due to vessel motion, leading to uncontrolled jerking.

FIG 4.1 — SPREADER BAR PIVOTING ON STERN CRADLE SUPPORT

Extending the centre upright cradle support to accommodate the spreader bar's incline angle during early tensioning would have provided a more stable and controlled lift profile.

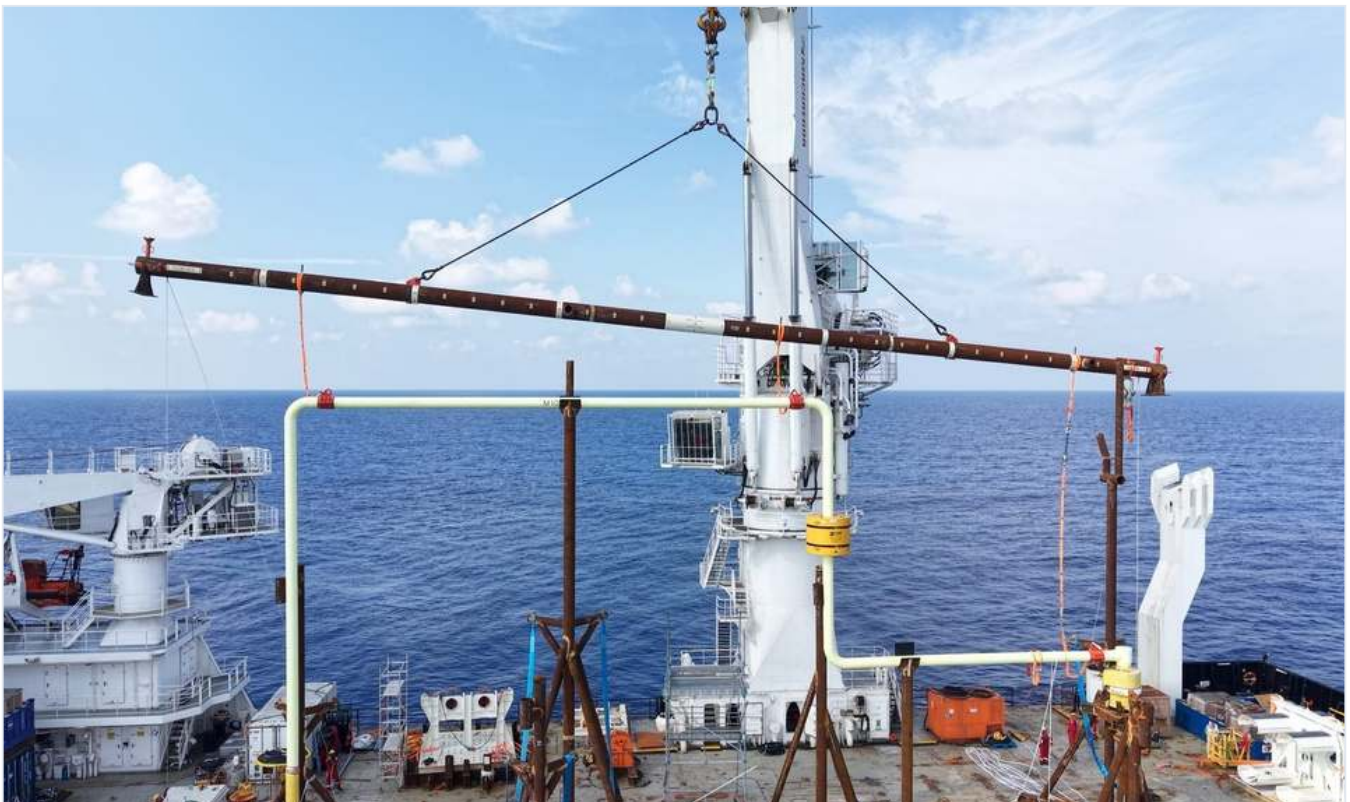
Upon closer review, drone footage revealed that shackles were secured on the spreader bar near the XT-HUB cradle support arm. During lifting, the spreader bar tilted due to load imbalance, causing horizontal travel. As a result, the clump weight made contact with the cradle arm. Given the clump weight was secured only by cargo straps and a sharp cutter release mechanism, this presented a significant dropped object risk had the strap parted under load or impact.

FIG 4.2 — CLUMP WEIGHT CONTACT ZONE AT CRADLE ARM

Position shackles further from structural contact zones and revalidate tie-down security under all potential travel angles.

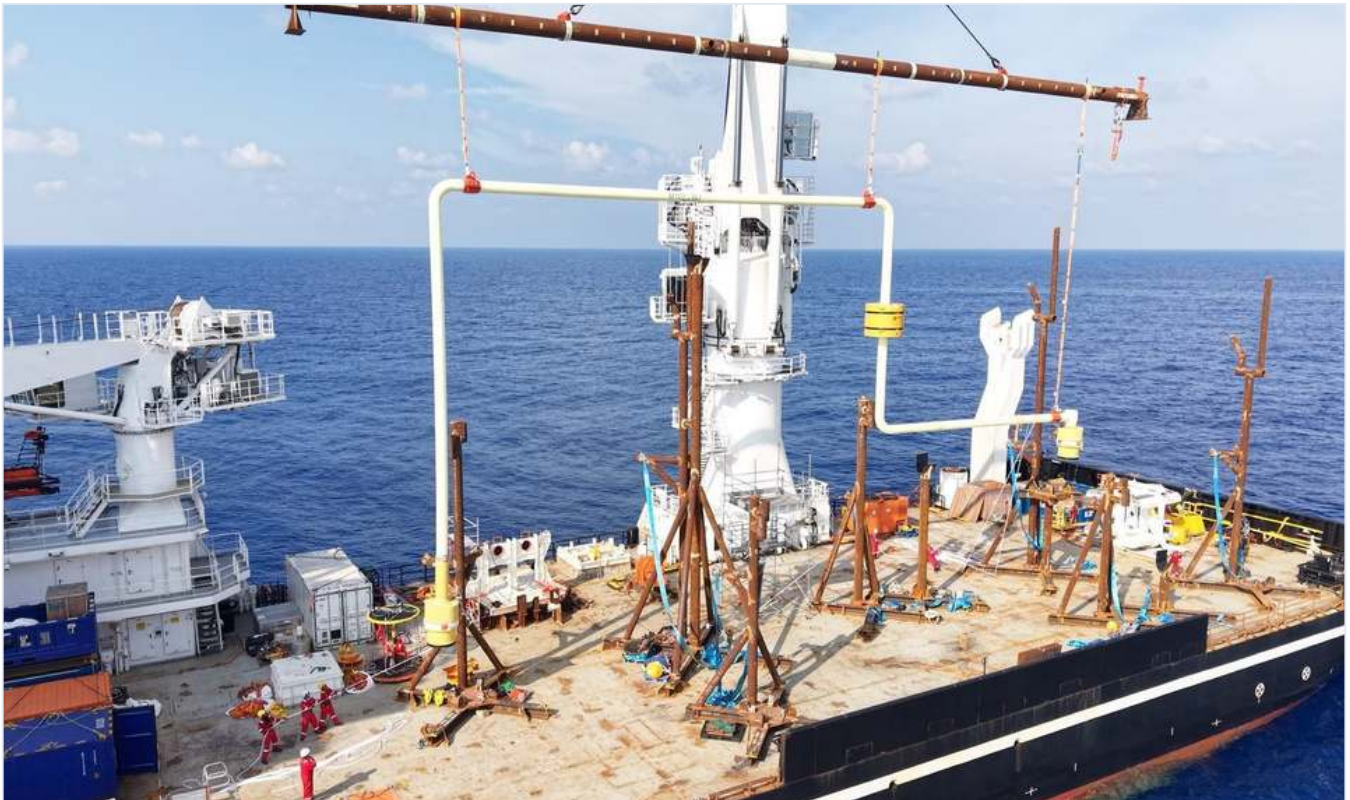
The forward cradle support should be extended further to mitigate spool flexibility during lift-off. Once the jumper was released from its cradles, flexible movement introduced by spool dynamics created the potential for the jumper to travel behind the cradle. This posed a risk of the jumper becoming trapped or entangled, which would have introduced serious challenges during deployment mode, especially if real-time detangling was required.

FIG 4.3 — JUMPER ROUTING AT FORWARD CRADLE

Extend the forward cradle to maintain control over jumper routing during free-swing, ensuring consistent separation and clear line of sight for safe deployment.

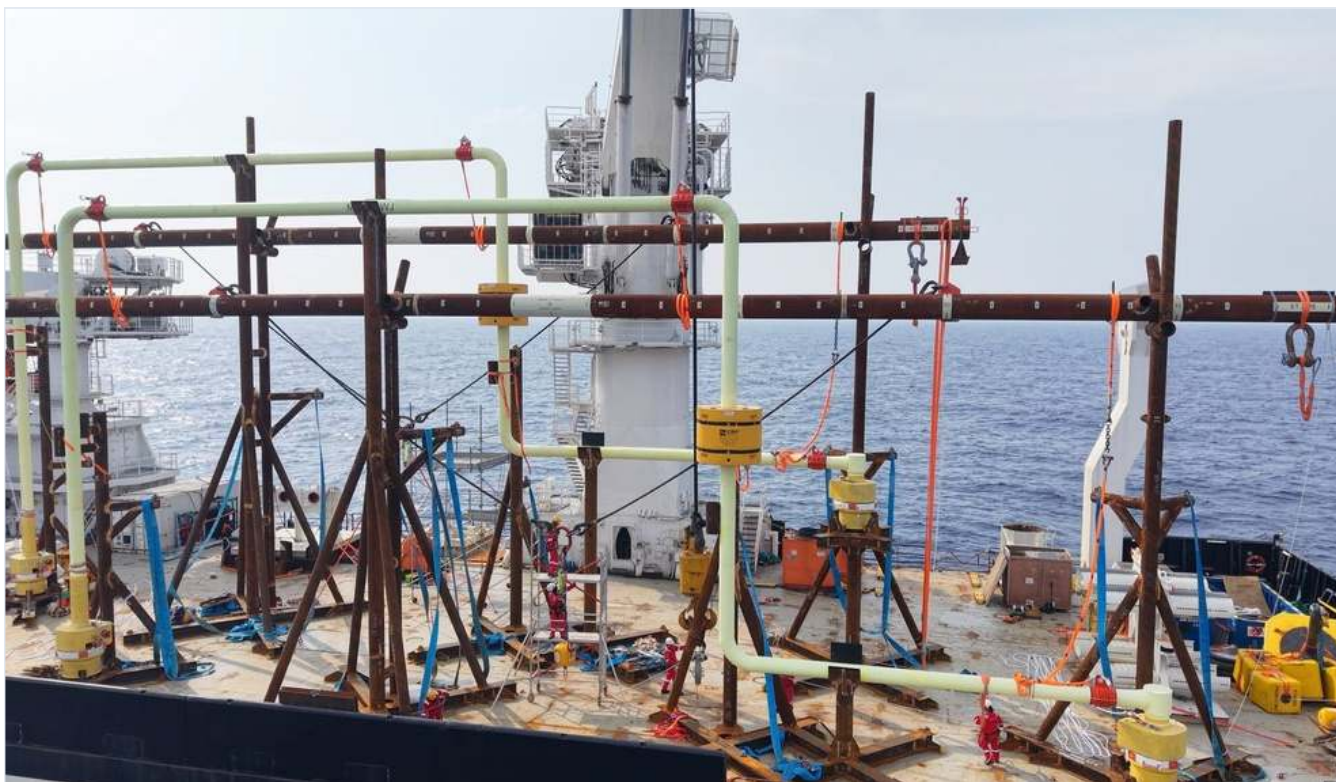
PLATE A-4 — SOFT SLINGS — DRESSING & TAPING CONDITION

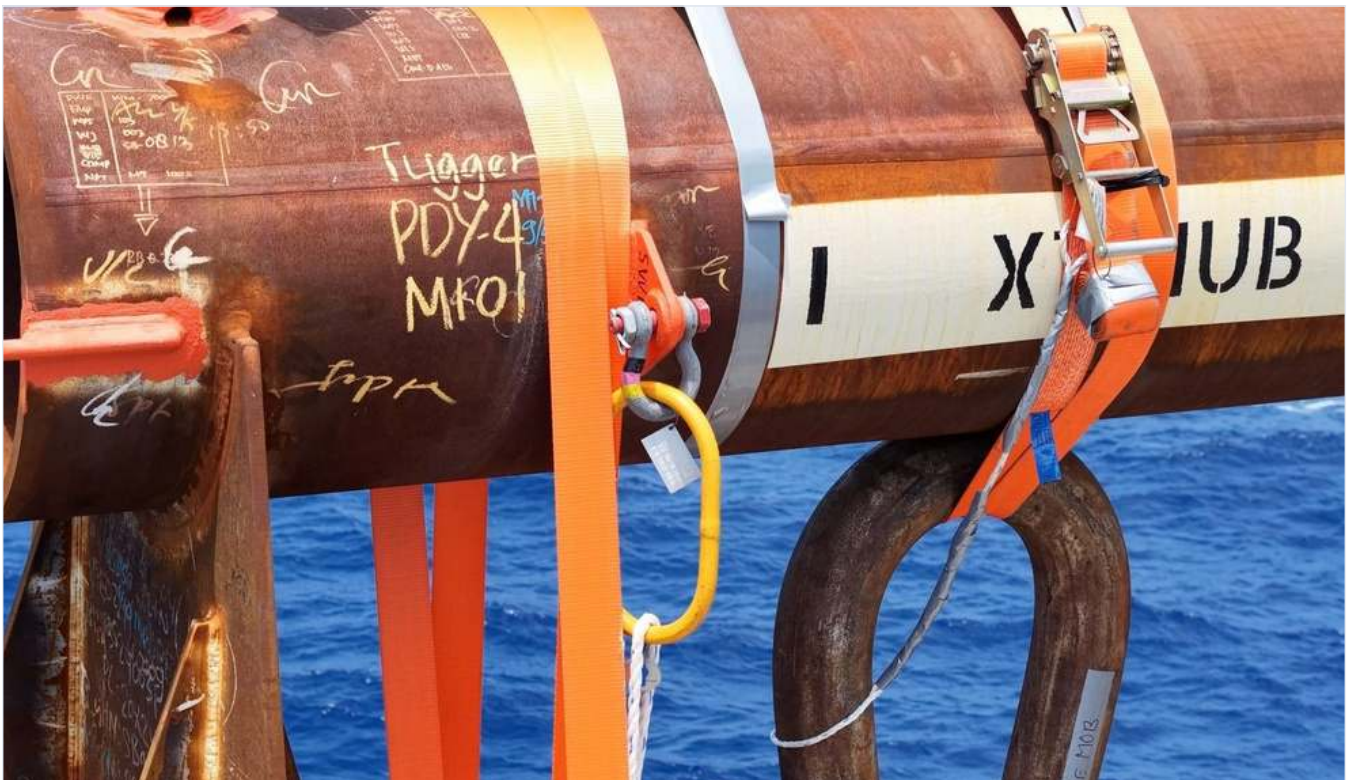
PLATE A-6 — CLUMP WEIGHT — RESTRAINT & CUT-AWAY RELEASE
