DRONE-ASSISTED VISUAL INSPECTION · PRE-DEPLOYMENT

Pre-Deployment Rigging Inspection

[REDACTED]	REVISION 0	[REDACTED] 16
[REDACTED]		PREPARED BY AURORA MEDIA HUB

Drone-assisted visual inspection of rigging aids and lifting equipment ahead of the lifting and installation of [REDACTED] assets, conducted under [REDACTED] – Management of Change.

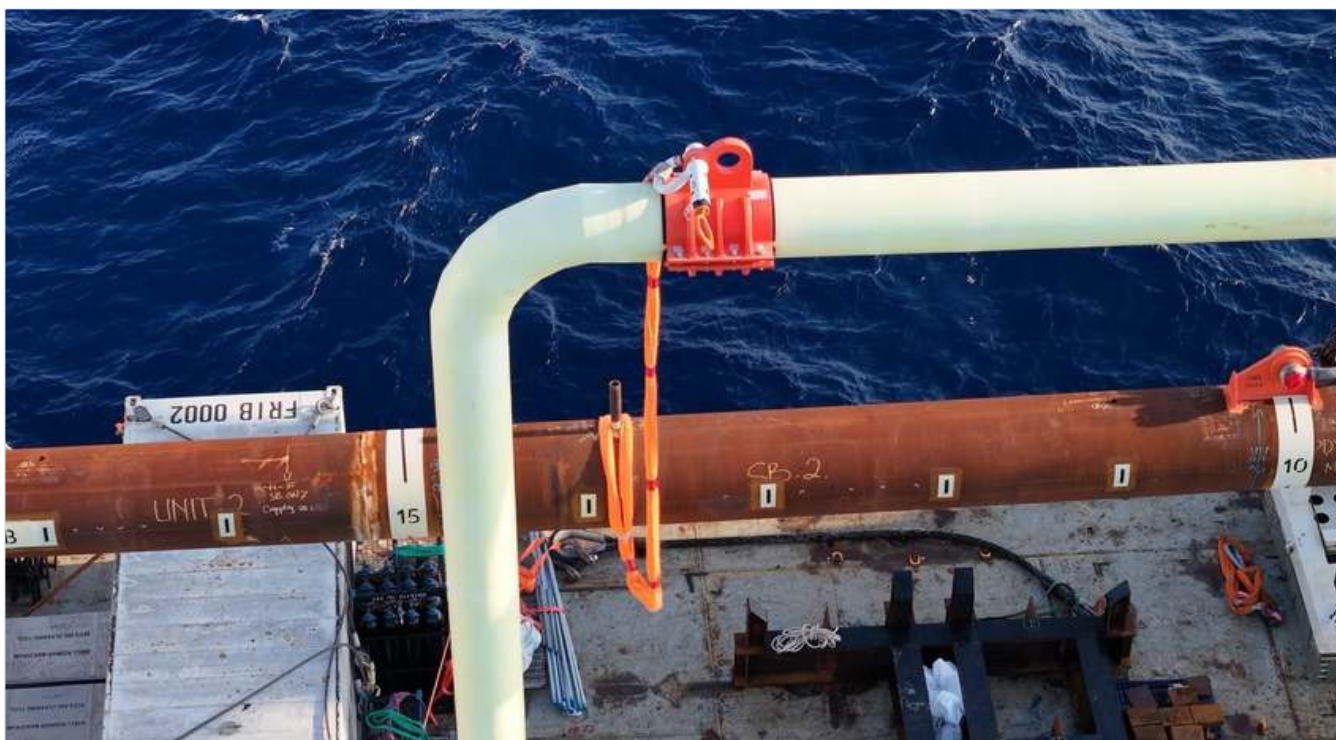
PLATE A-2 — ROV SHACKLE 2, CENTRE — DECK OVERVIEW

Inspection of Shackle 2 revealed that a pin was again present within the shackle body. No deviation from intended setup was observed, and the hardware remains in a mechanically sound configuration.

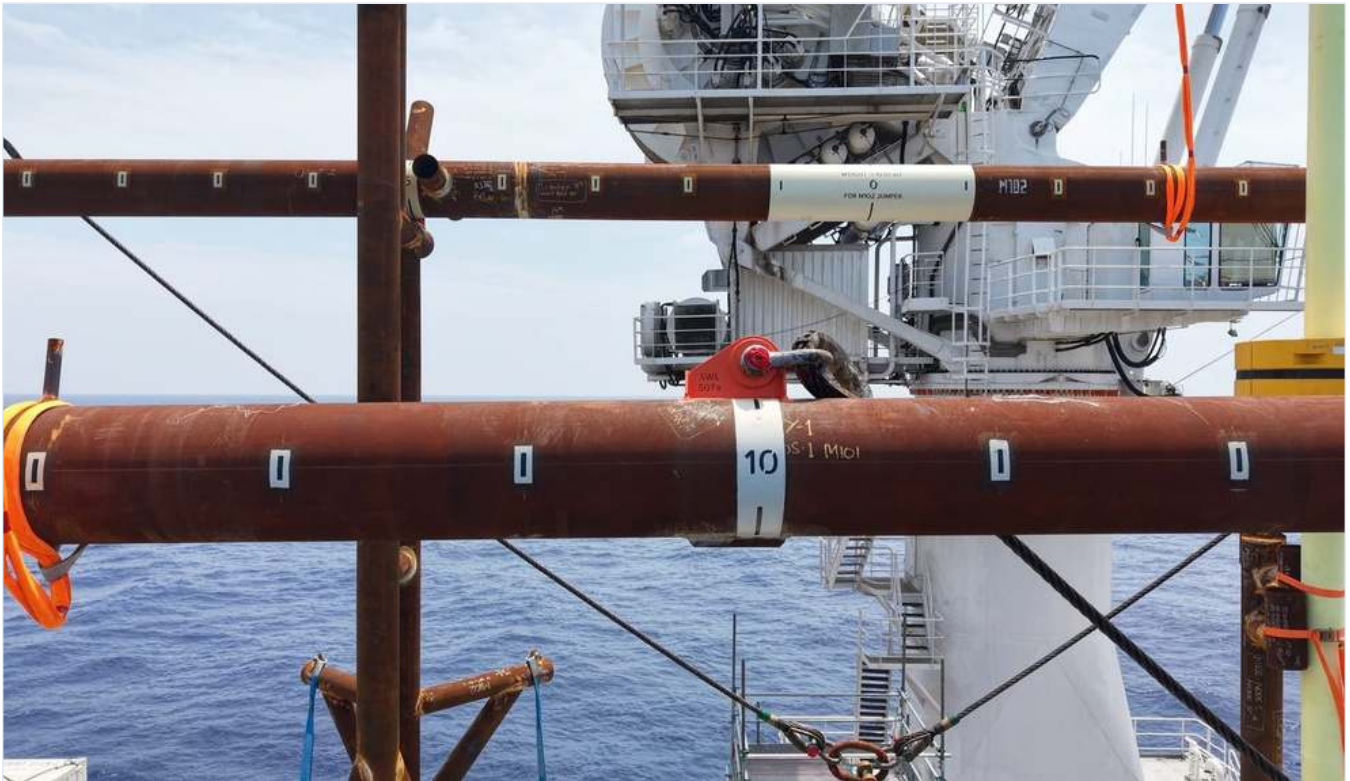
PLATE A-5 — SPREADER BAR — RIGGING ARRANGEMENT

Chains were observed hanging near the cradle support arm, with one shackle and lift sling located in close proximity to this area. This configuration introduces a potential snag risk during lift-off or dynamic motion. Shackle and sling condition at the spreader bar connections is covered under the overview in Section 3.3.

It is advised to remove the cradle lift sling and associated shackle to eliminate this snag point. The active shackle currently in use was observed to seat the soft sling eye cleanly on the pin, with additional taping applied to prevent rotational movement of the eye. This taping ensures the sling and shackle do not rotate, allowing for even weight distribution and preserved balance during lift execution.

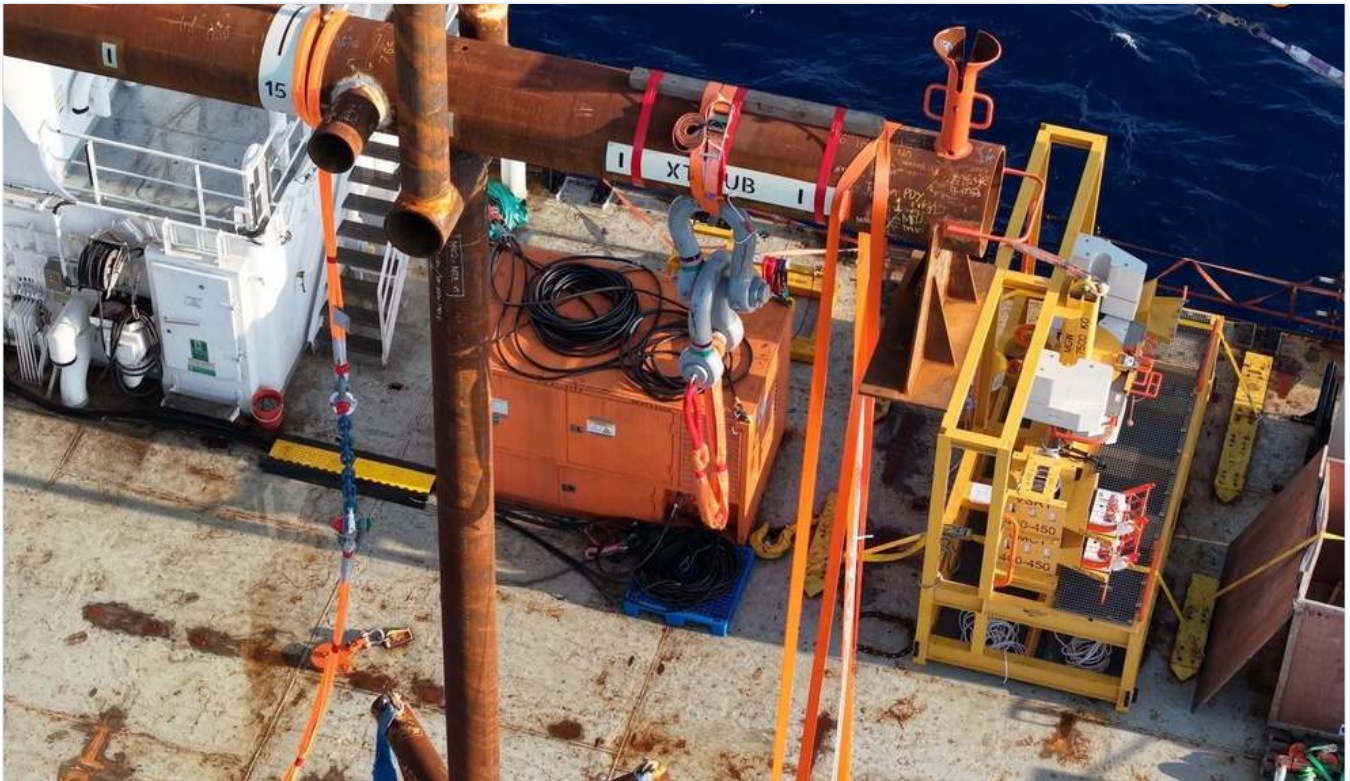
PLATE A-7 — CLUMP WEIGHT — TRANSIT CONDITION

During transit to the installation location, the clump weights were subject to repeated visual inspections due to elevated vibration levels caused by wind and vessel movement. These dynamic conditions introduced inherent risks, particularly around the method of shackle restraint.

Aerial drone footage confirmed that all shackle assemblies remained in a safe, stable condition, with no visible evidence of movement, interference, or hazard escalation.
